Safety valves provide zero leakage

Y-shaped valves save operating costs in ethylene copolymer unit

Braytun O. Paul, Technical Editor

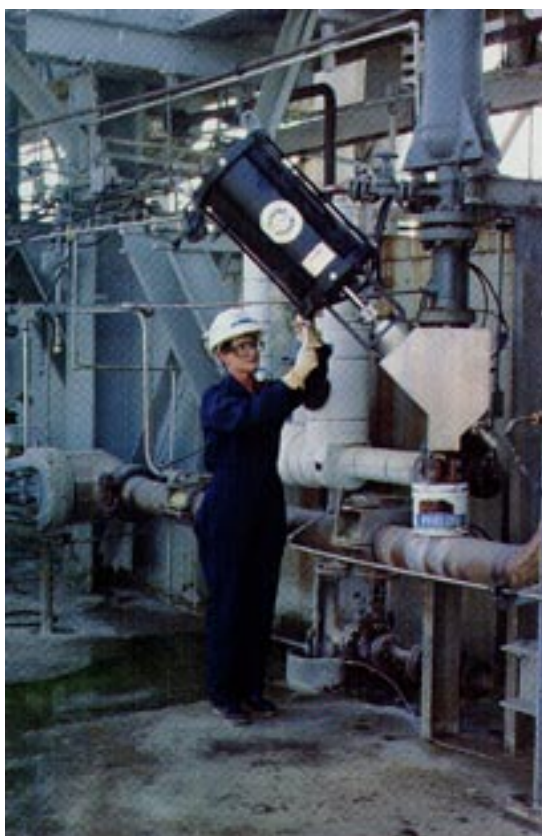
Y-conduit valves provide soft-seat, bubble-tight shutoff at pressures to 8,000 psi in fire protection vent application.

The new valve design includes advanced metallurgy for the body and trim, made from 15-5 precipitate hardness stainless steel to strengthen the assembly; a new plug and actuator assembly, with general improvements to meet both operational and maintenance requirements; and an improved seat design, made from a high-strength, corrosion-resistant alloy steel.

The manufacturer specified the high-pressure valves at 10,000 psi, modifying the internal design to meet requirements. The maximum pressure range of these conventional soft-seat, bubble-tight designs were previously 4,000-6,000 psi. The design team developed a high-pressure unsupported dynamic seal, made from poly ether ether ketone (PEEK), for service to 10,000 psi.

The valve has more clamping or closing force because the actuator is bigger, designed to crush any polymer that might be present on the seating area.
