Control Components Solves Critical Valve Problems on North Sea Oil Platform

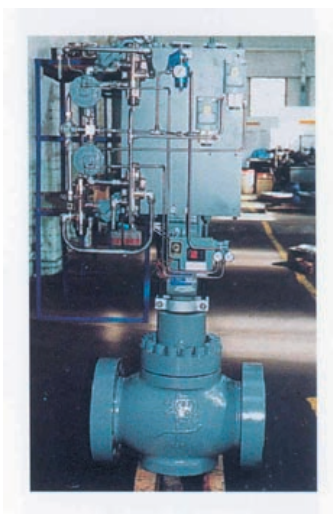
8", 1500 ANSI Compressor recycle valve retrofitted with DRAG trim

to take the platform's spare valves, machine the interiors for retrofit, and install new DRAG trim. This would save the cost of casting new valve bodies and would also meet critical maintenance deadlines.

DRAG valves technology was selected for use in this severe service application for several reasons. First, the multi-stage, stacked disk design would better control gas velocities through the valve as pressures were reduced over twenty-fold. With better velocity control would come a reduction in noise and the elimination of erosion on the seating face. This would yield greater control over gas flow. Second, platform engineers were shown early-on trim and valve design would give them a quicker response in modulation mode and would give them better positioning stability because of the valves' overall greater integrity. Third, CCI's quick turn-around capabilities would allow them to meet the tight deadlines they found themselves up against.

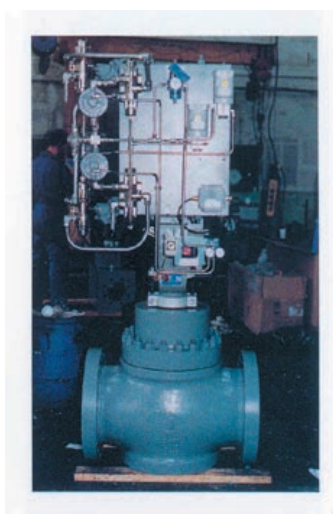
12", 600 ANSI Compressor recycle valve retrofitted with DRAG trim
